LOS ANGELES COUNTY ARBORETUM & BOTANIC GARDEN

Gate House Building Rehabilitation Study

Prepared for
Los Angeles Arboretum and Botanic Garden Foundation

March 3, 2022

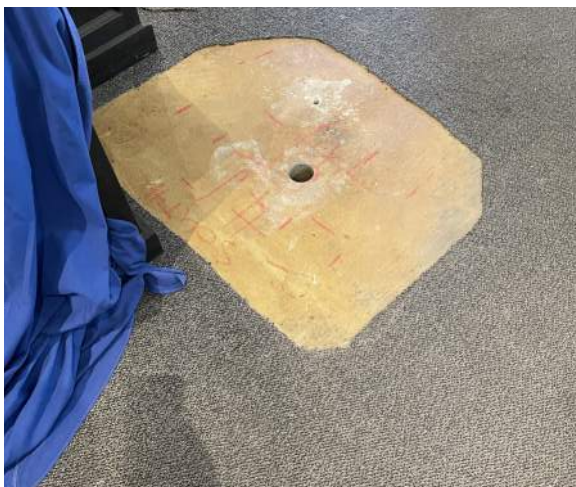
Section of carpet removed at gift shop floor for concrete core sampling

An opening in the slab under the roof to the northwest of the concrete block enclosure allowed for an in-ground planter feature. It appears from preliminary investigation that this planter opening was later infilled. Due to the existing and on-going use of the gift shop, the carpet covering the original exterior slab has not been removed. The condition of the concrete slab appears to be in good condition but will require further examination once the carpet has been completely removed.

- Remove carpeting and adhesives at the exterior (previous gift shop enclosure) and interior (ticketing office and hallway) floors to identify crack locations and level of repair work.
- Clean and repair existing colored concrete slab-on-grade.
- Repair cracks and spall repairs as needed.
- Identify where previous planter infill occurred.
- Repoint cracks or voids in grout at CMU walls; match existing grout.
- Surface preparation and repainting at concrete block walls.
- Prep and waterproof the back side of the north concrete block wall to prevent material deterioration.

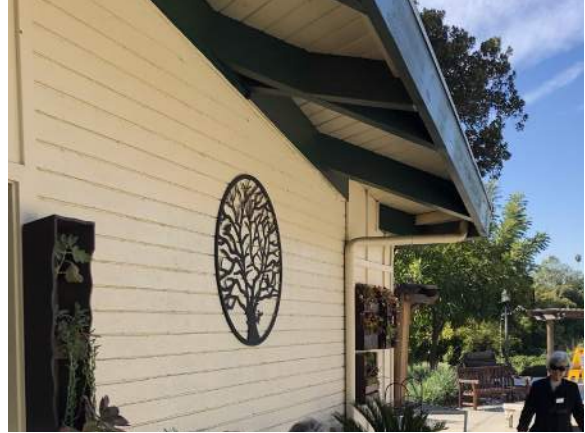
The CMU wall along the north side of the building has been performing with some retaining capacity for the landscaped slope between the Gate House, Administration Building, and the Library. Water intrusion has been noted along the current Gift Shop entry side of this wall and the low retaining wall where soil sits against. Some efflorescence has been seen on the concrete floor that is likely the result of this intrusion.

Northwest concrete block wall

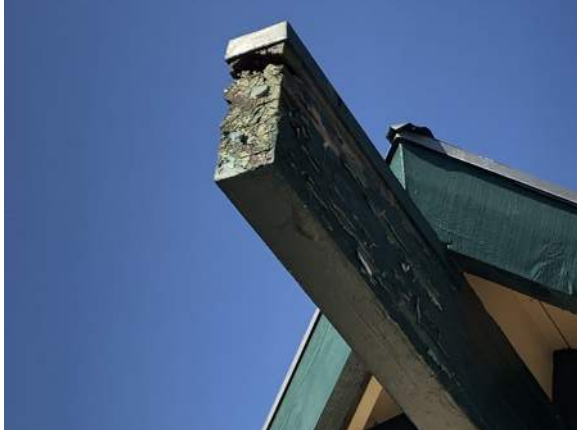
South end of extended ridge beam

- Remove non-original wood panel wall enclosures at original openings under Gate House Roof.
- Remove wood paneling from south corner windows and assess conditions of existing wood window framing.
- Remove wood display case from east CMU wall.
- Remove peeling paint and decayed areas of wood and debris, old patching materials, corroded fasteners, etc.
- Localized wood repair of deteriorated and split wood components. Use wood-compatible epoxy fills where possible; if new wood is required, use dutchman repairs rather than full board replacement to retain as much historic fabric as possible.
- Repair original wood ridge beam, rafters, and fascia trim.
- Repair original roof sheathing T&G as needed.
- Provide new cap flashing with drip edge at all exposed framing.
- Repair exposed ends of existing ridge beam.
- Generalized cleaning and repainting.

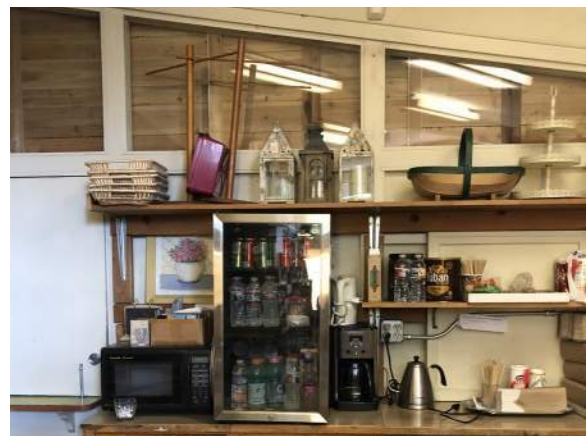
Covered north windows

- Repair and restore original windows (wood frames, glazing) at south corner walls. Provide new UV films and shades.
- Repaint wood surfaces at sash, frame and trim.
- Remove non-original door at south corner. Rebuild window condition to match existing.
- Clean, repair existing original exterior and interior doors. Reuse where possible.
- Retrofit door hardware to accommodate new ADA lever hardware.
- Rehabilitate original ticketing windows at north wall.
- Remove skylights in roof.
- Uncover roof framing at north end to match original configuration.
- Clean vents in north side CMU walls.
- Remove old, unused equipment from mechanical openings in south CMU walls. Reuse existing mechanical openings for new infrastructure, where possible.

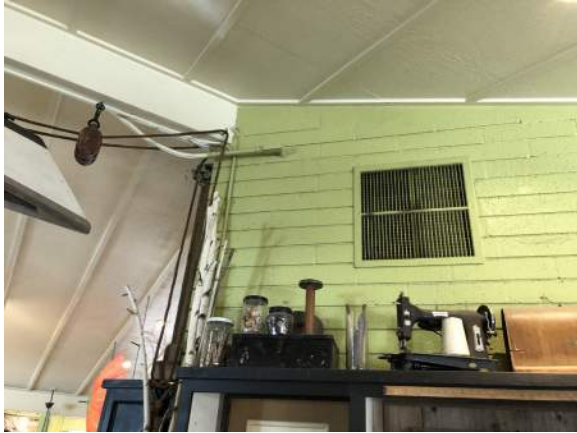
HVAC vent at CMU wall

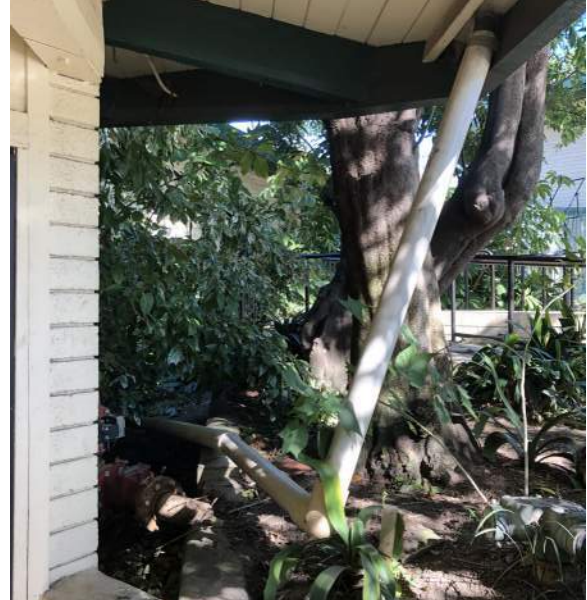
A PVC downspout attaches to the bottom of the gutter along the northeast wall and distributes runoff into the planter behind the Gate House. Along the west side, a downspout kicks back to the south end of the freestanding CMU wall and follows down to the grade. However, the downspout daylights and does not connect with

Downspout at northeast side

- Repair existing built-in gutter, replace existing downspouts, and connect to drainage system.
- Retrofit gutters with new mesh debris screens.
- Remove existing non-original skylights. Infill openings with new framing, ceiling panels/trim, and roof system to match existing.
- Return roof to original exposed structure.
- Install new structural sheathing over existing T&G.
- Install new composite roofing system.

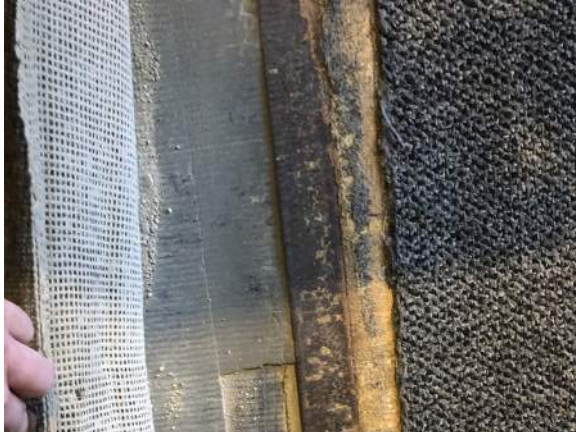
ACT at Ticketing Floor

- Remove non-original carpet.
- Remove loose VCT tile and replace with matching.
- Clean and repair existing tile at restroom. RegROUT floor.
- Clean and prep exposed concrete slab floors.

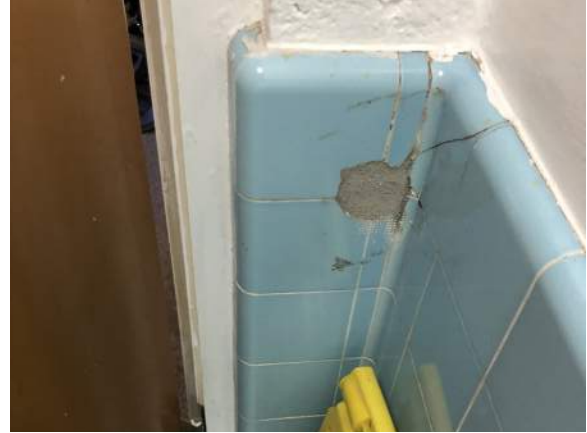
The bathroom walls are tiled to a wainscot height with a light blue 4x4 square tile in a stacked bond pattern. The cove base tile is flush with the floor tile. The tile bullnoses at the top of the wainscotting and at the corners. The tile is in fair condition as there are some large cracks and previous patching.

Bathroom wall tile

- Prep and repaint interior walls.
- Clean and repaint wood base throughout.
- General cleaning, stain and mineral deposit removal of ceramic wall tile.
- Repoint cracks or voids in grout; match existing grout.
- Replace broken/ missing tile with new to match.

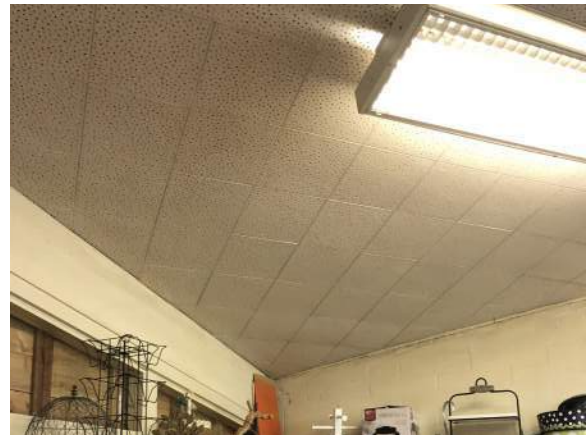
The ceiling inside the original enclosure is acoustic tile attached directly to the 2" x 3" stripping along the underside of the roof framing. There is some staining and evidence of previous minor water damage in areas near the perimeter walls. The tile is original. The ceilings at the hallway and small office are lower with the acoustic tile attached to framing. A ceiling hatch is framed out in the office ceiling.

Acoustic ceiling tile at ticketing office

- Clean existing acoustic tile to remain. Secure or re-attach any loose tiles.
- Prep and repaint.

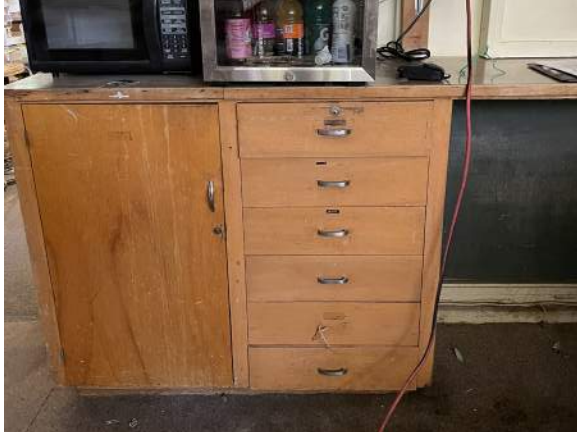
Built-in cabinetry at ticketing office

- Salvage and reuse as much original casework and hardware as possible.
- Where materials are reused, clean and repair.
- Replace broken fixtures.

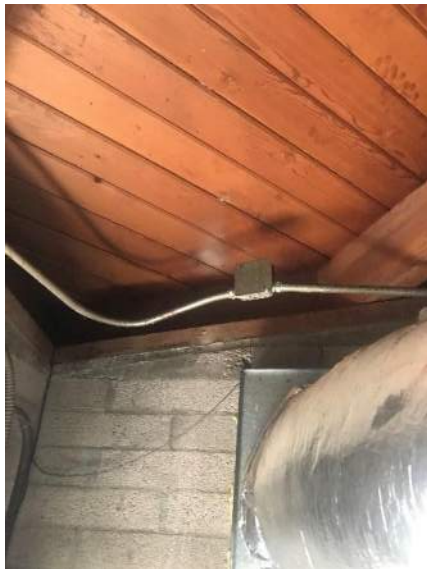
The existing building appears to be in generally fair condition with no sign of major structural distress. There are some signs of deterioration on the existing wood fascia and exposed roof rafter tails due to water exposure. At one rafter, which had water and termite damage, was previously repaired by sistering an additional 2x member to the original rafter.

Figure 2 - Straight sheathing at roof

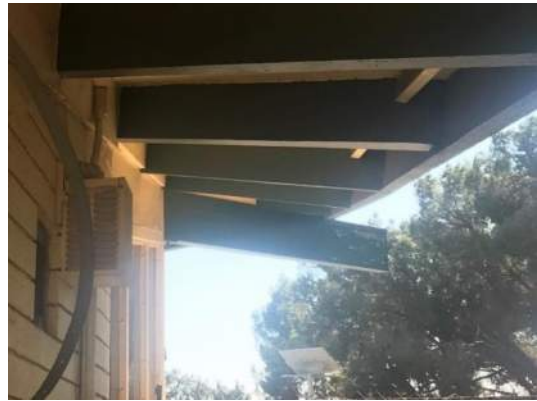
The majority of the wood damage occurs along the wood perimeter roof fascia where it appears water from the recessed gutter has permeated into the wood and become trapped behind paint.

Figure 3 - Roof rafter tail deterioration
