LOS ANGELES COUNTY ARBORETUM & BOTANIC GARDEN

Gate House Building Rehabilitation Study

Prepared for
Los Angeles Arboretum and Botanic Garden Foundation

March 3, 2022

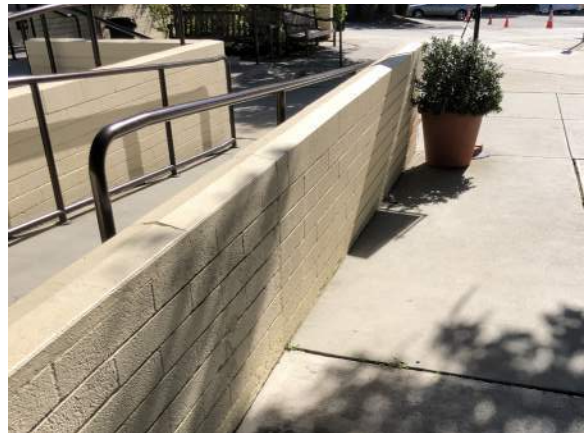
low concrete block wall off Gate House

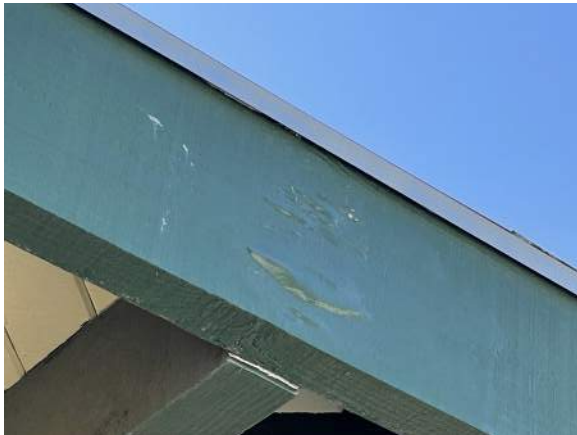
example of bubbling at wood fascia

The majority of the wood damage occurs along the wood perimeter roof fascia where it appears water from the recessed gutter has permeated into the wood and become trapped behind paint.

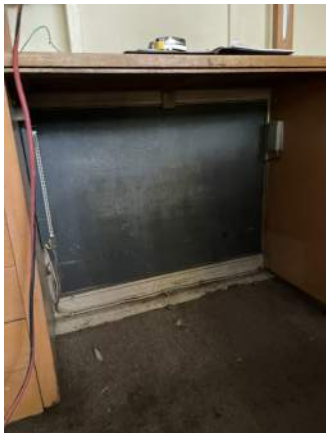
interior view of "cement asbestos" panels

Original wood framed windows are still intact along the upper level of the south corner. The wood is painted and appears to be in good condition. The lower level infill paneling beneath the windows is intact along the north side and identified on the drawings as half inch thick "cement asbestos" panels.

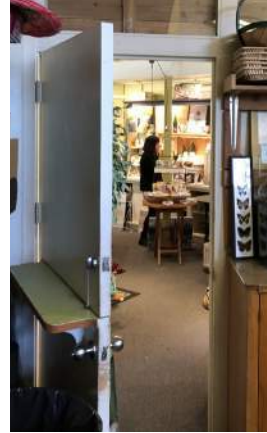
North Exterior Door

According to the original drawings, the three original exterior doors were Kalamein slab doors with no openings.¹ They have since been altered so that the primary door can act as a Dutch door and the secondary door has a square opening at the top with wire-glass. Door hardware on original doors is commercial grade stainless steel knobs.

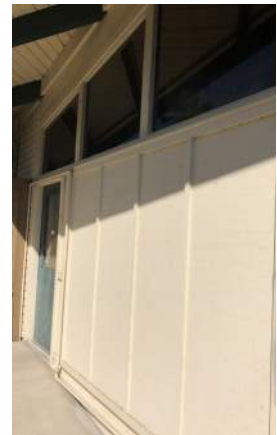
The original windows are still in place within the north wall and the southeast and southwest corner. The original sliding ticketing window is still in place and visible from the interior of the block building. The sliding window located along the southeast wall is covered on the exterior by siding and on the interior by shelving at the lower windows and canvas covered frames at the top windows. It is not certain that the operable ticket window is still in place at this location. The glazing that is visible in the upper windows is fixed within the framing and is a clear float glass.

Covered windows

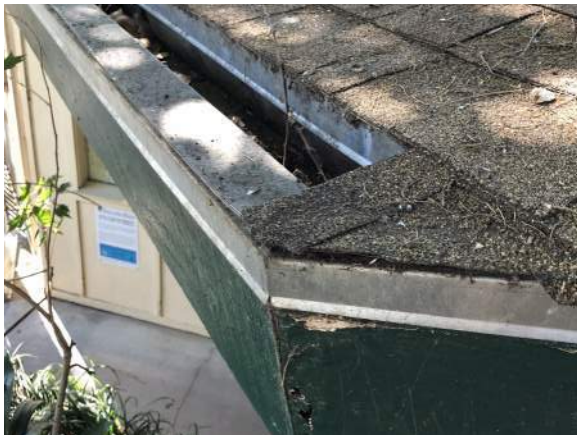
Recessed gutter

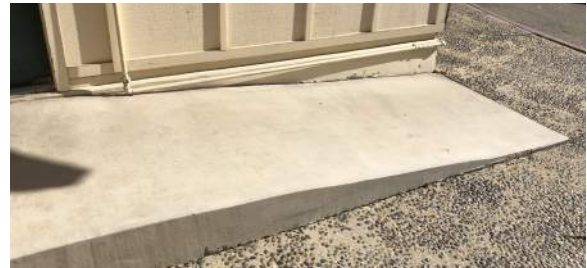
Multiple exterior slab expansions have tried to extend the original grid pattern and but have not matched the original slab color. Additional sloped walkways were placed at the exterior of the west gift shop exit door and the south exterior staff door to accommodate the change in grades and accessibility.

sloped walk at southeast side

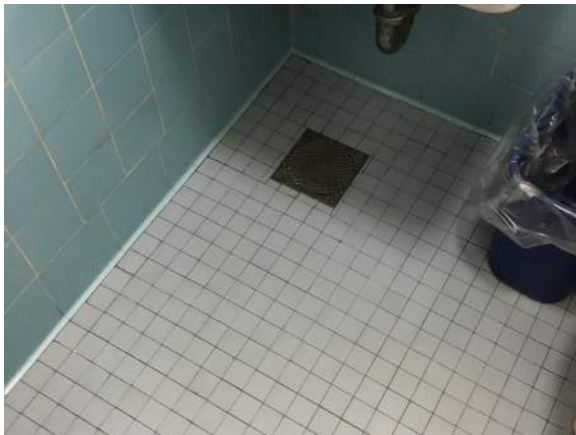
Restroom floor

The bathroom floor is a 2x2 gray tile floor inset flush with the adjacent floor. An inset floor drain is located below the sink. A gray marble threshold runs across the door opening. The floor tile has some crack locations and is in fair condition.

- Remove non-original carpet.
- Remove loose VCT tile and replace with matching.
- Clean and repair existing tile at restroom. RegROUT floor.
- Clean and prep exposed concrete slab floors.

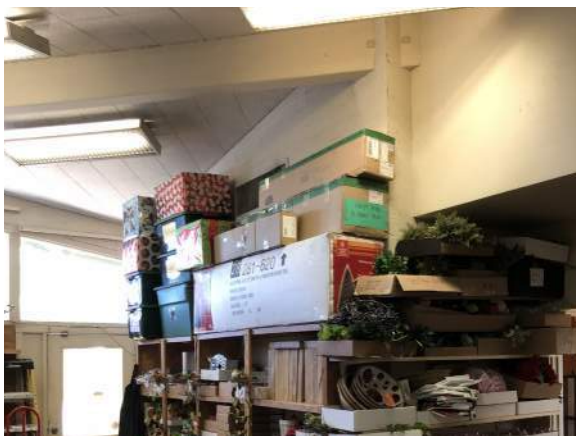
Interior concrete block wall

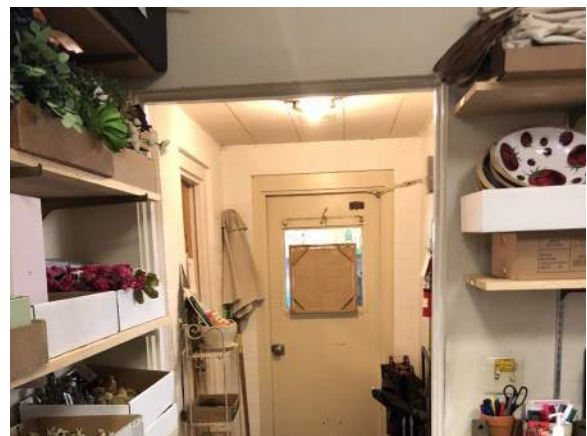
Dropped ceiling at hallway

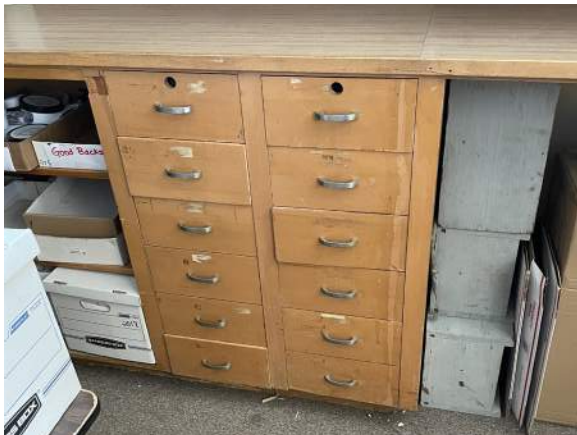
Built-in cabinetry at ticketing office

- Salvage and reuse as much original casework and hardware as possible.
- Where materials are reused, clean and repair.
- Replace broken fixtures.

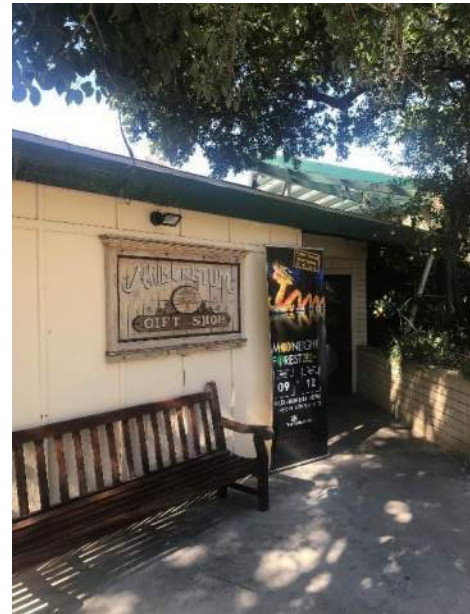
Figure 1 - Gift Shop exterior

Constructed in 1958, the former Gate House building was a single-story square building, approximately 26 feet wide and 26 feet long. The original building footprint was approximately 650 sf. The roof is hexagonal and set 45° to the building, spanning from the building to two freestanding walls approximately 40 feet north of the building, creating a covered outdoor area in between the building and the walls. Renovated circa 1980s, the existing Gift Shop is a single-story hexagonal building, approximately 38 feet wide by 76 feet long. The building footprint is approximately 2000 sf. Light-framed, non-bearing walls were added to enclose the area between the original building and the freestanding walls (see Fig. 1).
